Albertson Engineering Inc.

RE: 1219 W Main St. Assessment
Sturgis, SD
Albertson Engineering File #2020-383

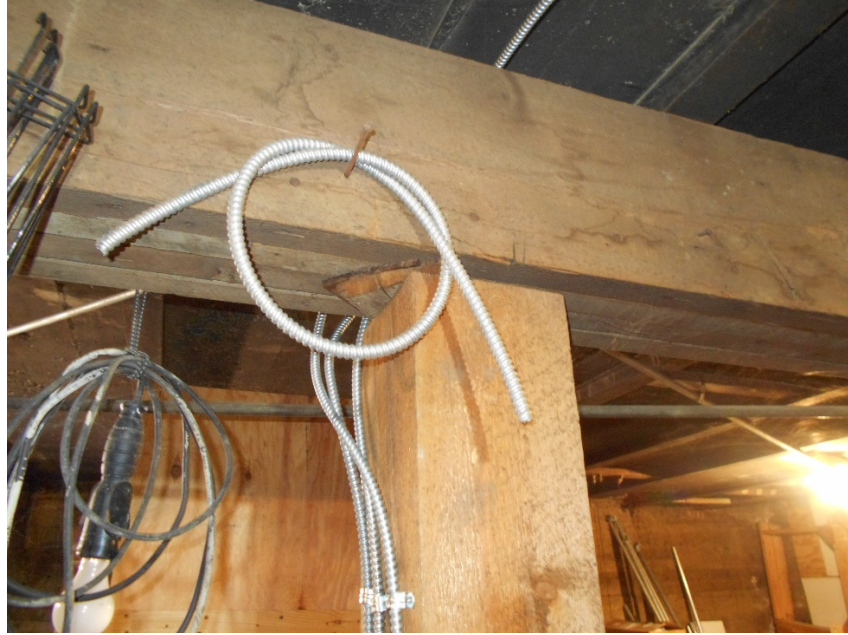
- The floor of the basement is likely a concrete slab on grade. Concrete surface appears to be in good condition.
- The interior posts in the basement did not appear to have a connection to the beams at the top nor to the concrete floor at the bottom. In some locations a wood shim was added in the gap between the top of post and bottom of beam indicating only a friction fit. (photo 1)

Photo 1: Wood shim in between post and beam

- The framing supporting the main floor slab in the basement area should be analyzed if the use of the main floor space is to be changed. At a minimum there should be positive connections provided between the posts and beam at the top and floor at the bottom. We can provide connection details if required.

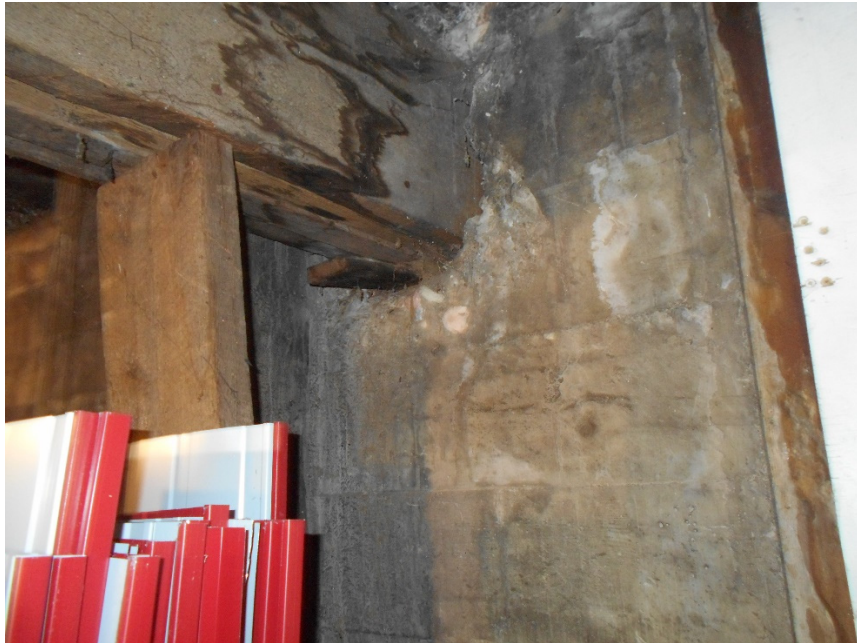
- At the concrete basement walls where the wood beams tied in it appears that a rough cut pocket was provided for the wood beam to sit on. Some locations had wood shims in between the bottom of the beam and the concrete pocket (photo 2)

Photo 2: beam bearing on concrete pocket in wall with shim

- Wood members being supported by concrete should have a moisture barrier provided in between the surfaces to mitigate the influx of moisture into the wood.

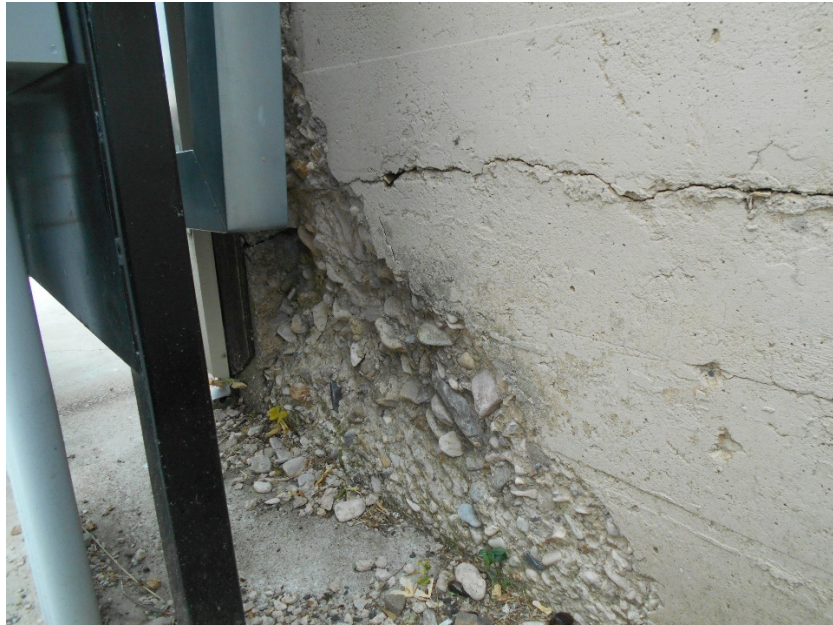
- The foundation of the main building was not observed due to it being buried.
- The exterior walls of the building are believed to be made up of concrete throughout. Finishes covered the walls in most of the interior with some of the original concrete being exposed in some spots. Exterior finishes covered the south, east, and west walls. The north wall concrete surface was completely exposed. The bottom section of the northeast corner showed some damage (photo 3). Cause of damage is unknown.

Photo 3: Damaged section of concrete wall on north east side

- The north wall has an area of damage and some cracking on the surface due to the age of the building and it being fully exposed. These areas can be a conduit for moisture infiltration into the building.
- The load capacity of the steel roof trusses has not been analyzed by AEI and is unknown. The effect on the truss of removing some of the web members is unknown.
- In areas of the roof where previous openings have appeared to have been infilled with framing, the joists on either side of the opening are carrying more load than the rest of the joists due to the header tying into the side of those joists. It is not known if the joists have the capacity to carry the additional load.

- The north wall is recommended to have some type of weather proof barrier/finish installed similar to the other walls. An architect or contractor specializing in this area should be retained to provide their expertise in this area. At a minimum the damaged area of wall should be repaired. We can provide notes and repair steps to complete a repair of the wall if the owner chooses to do so.

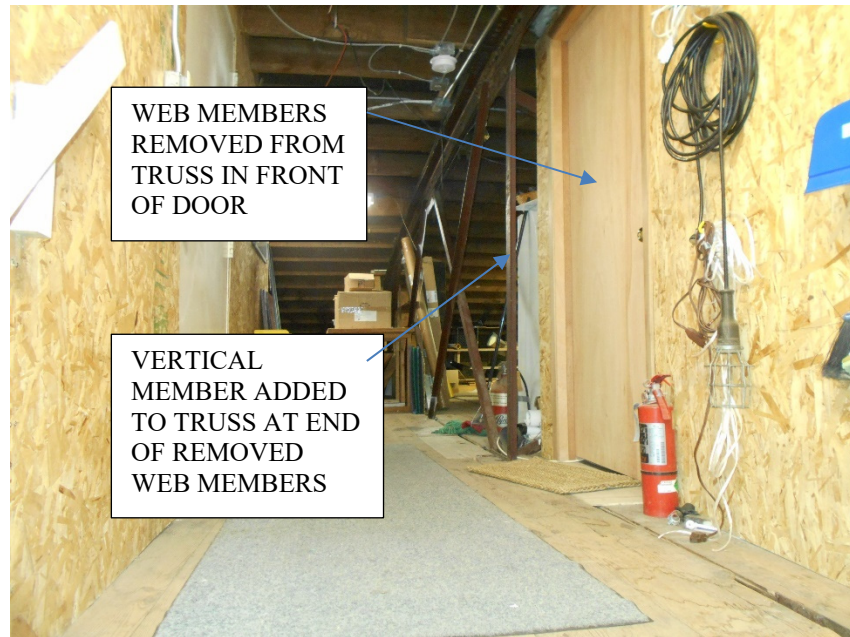
- Curved top chord steel trusses supported the roof framing. The steel trusses were composed of angles riveted together. The top and bottom chords were composed of double angles and the web members were single angles. Steel plates were used to connect the web member to the trusses. In one location some web members were removed for access to a door (photo 4). A vertical member was added at one end of the removed web members.

Photo 4: truss with web members removed

- The roof framing in infilled areas around previous openings and the steel trusses with web members removed should be analyzed to determine if the existing conditions have the capacity to carry the code required loading. We can provide an analysis of the framing if the owner chooses to do so.

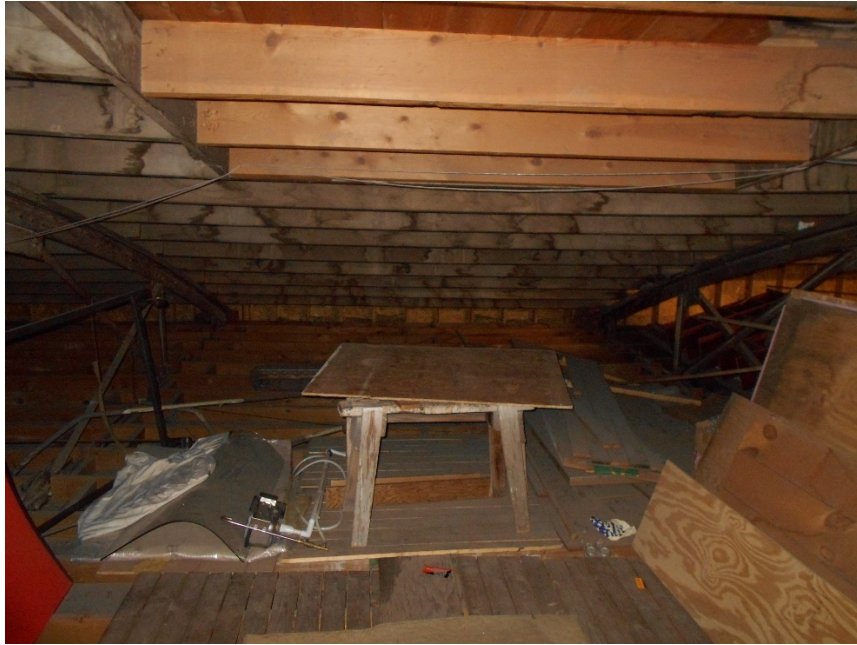
- 2x8 joists at 24" c.c. sat atop the steel joists which had a wood nailer plate bolted on top of the top chord. It appears in a few locations that openings in the roof framing had been infilled with newer joists (photo 5). At the south end wall the 2x joists were either pocketed into the concrete wall or fastened to a wood ledger that was attached to the concrete wall. Treated wood did not appear to be used. The north wall was not observed but is assumed to have a similar support condition.

Photo 5: Roof framing with newer infill framing
